Fatigue Cracks in Yanmar 4BY2 Engine Cover Brackets

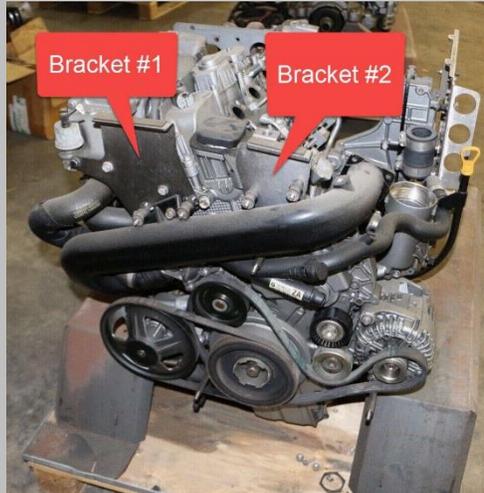
The two brackets which support the front of the sheet metal engine dress cover developed stress cracks after 1700 hours of engine operation.

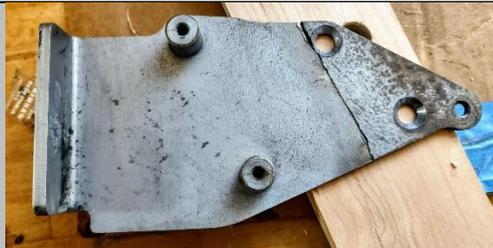
Bracket #2

This bracket was fracture completely thru. It was in two pieces when disassembled.

<p>Bracket #2</p> <p>Beveled edges of fracture and welded two pieces together. Welded steel piece to reinforce the area which fractured.</p>

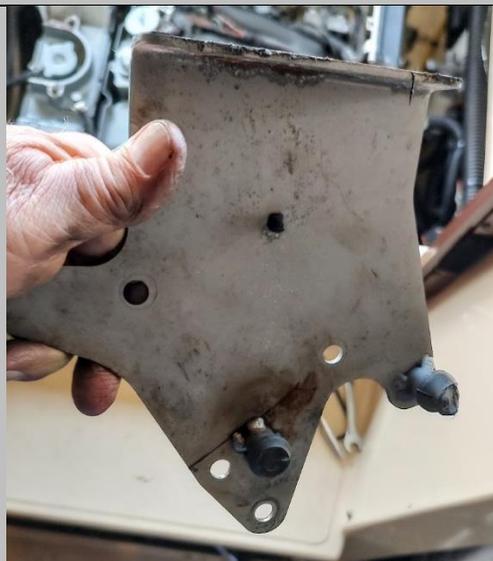
Bracket #1

This bracket had a long fracture near the mounting holes near the bottom.

<p>Bracket #1</p> <p>Drilled a thru hole at the end of the fracture to prevent further propagation. Used an Angle Grinder to bevel the edges of the fracture and then welded the two sides together</p>
